Fort George G. Meade

Former Pesticide Shop

Restoration Advisory Board Meeting January 16, 2014

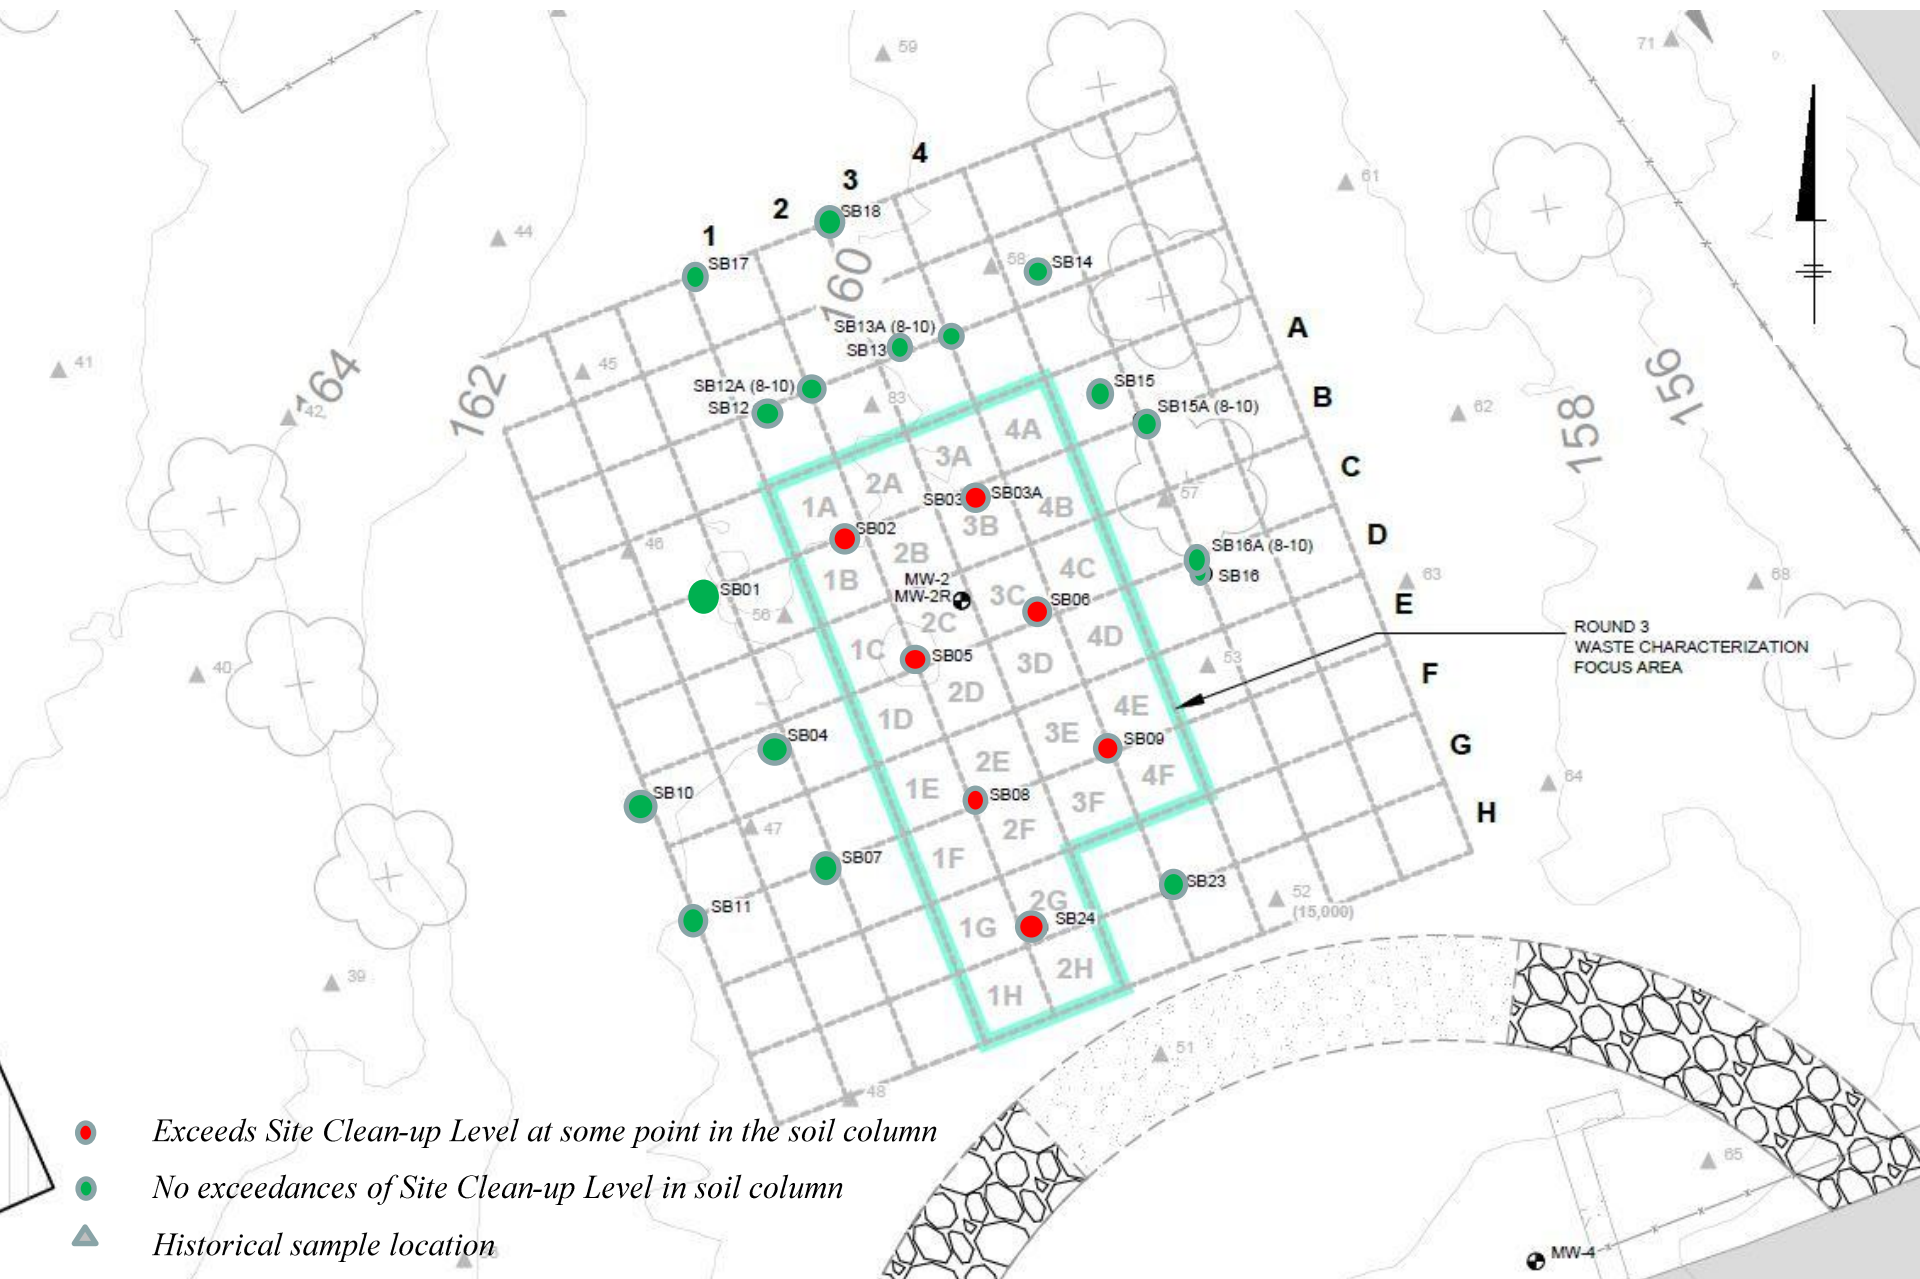
- The site is delineated.
- Contamination mostly limited to surface.
- Concentrations decline with depth.
- What do the colored grids mean?
 - Blue: Non-Hazardous--greater than 16 ppm. Passed TCLP leaching test
 - Lavender: Hazardous—Failed TCLP but less than 50 ppm (250 tons)
 - Orange: Hazardous—Failed TCLP and greater than 50 ppm (350 tons)
- Each of these waste streams needed to be handled differently going to 3 different off-site disposal facilities

- Increased Volume
 - Refined site characterization and understanding since the ROD
 - Additional depth of excavation
- Increased Cost
 - Due to additional soil volume
 - Due to “hazardous” soil (transport, treatment, and disposal)
- Captured in an “Explanation of Significant Differences” (11/07/2013)
 - Provides notification of a proposed change to the remedy that deviates from the ROD but is not a different remedy
 - Included as part of the administrative record
- The changes noted here do not adversely affect the outcome of the remedy

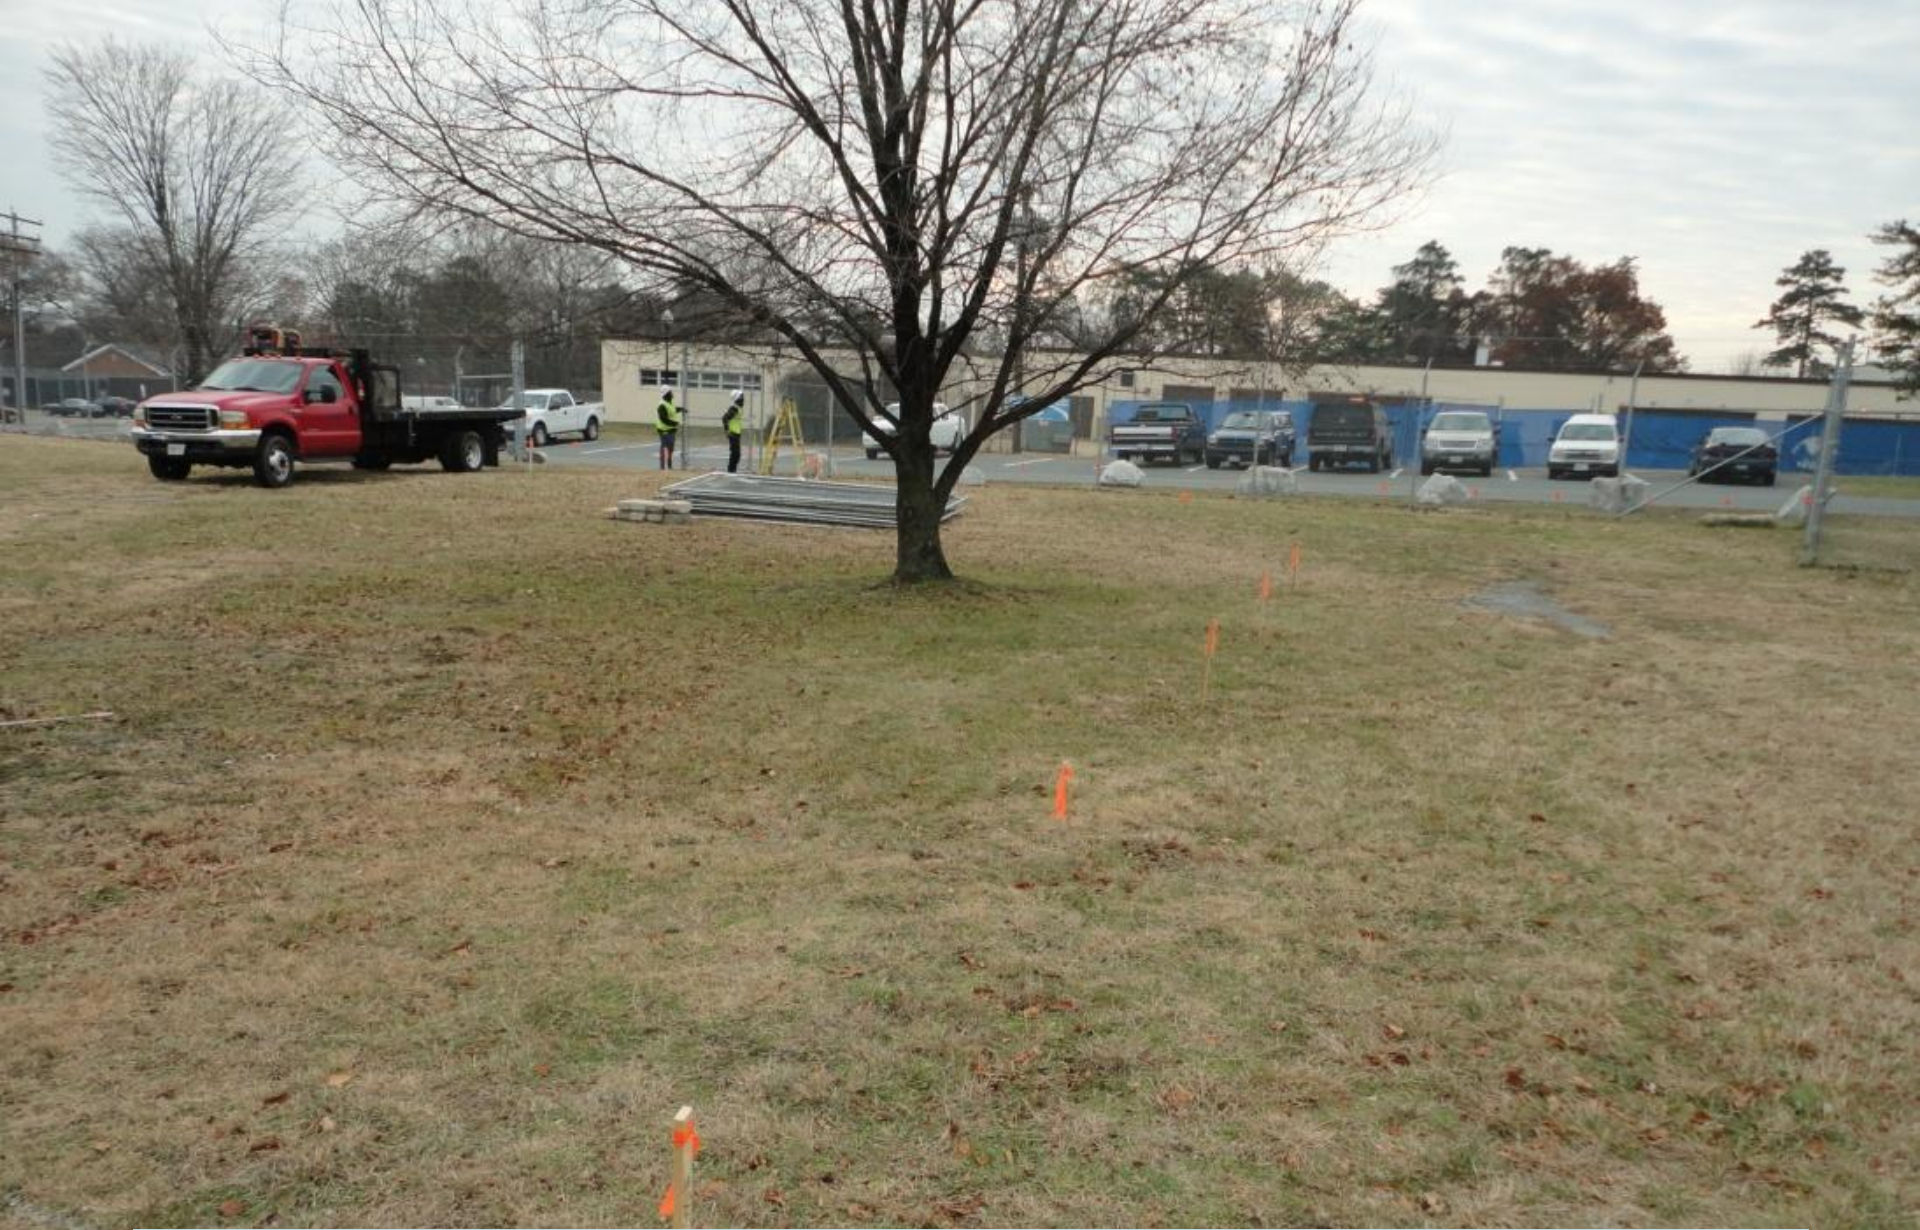
Site Preparation (Facing South): survey control and perimeter security

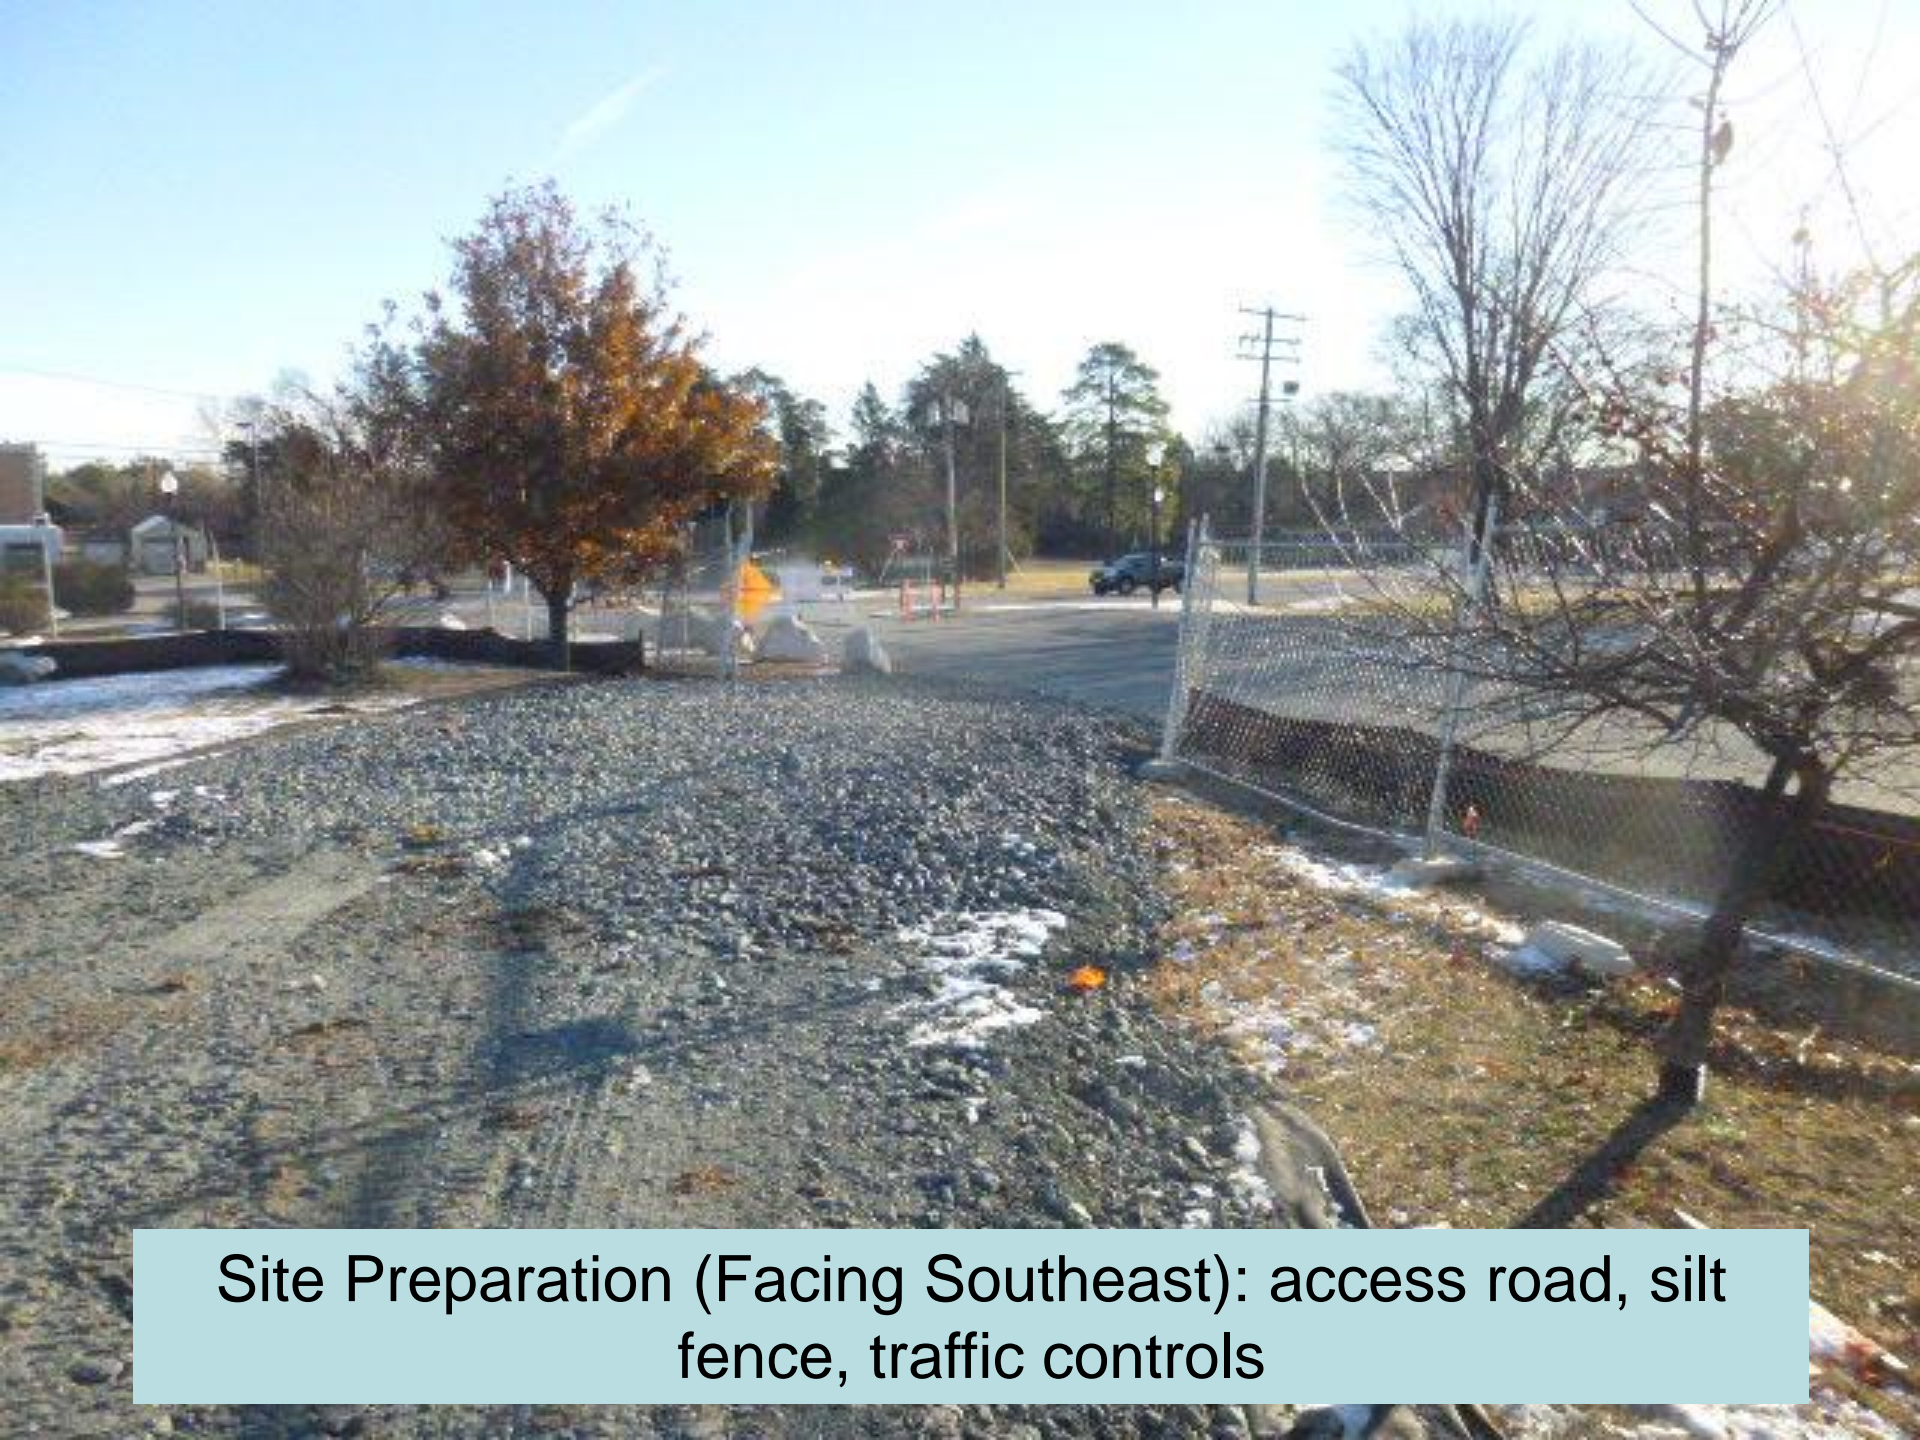
Site Preparation (Facing Southeast): access road, silt fence, traffic controls

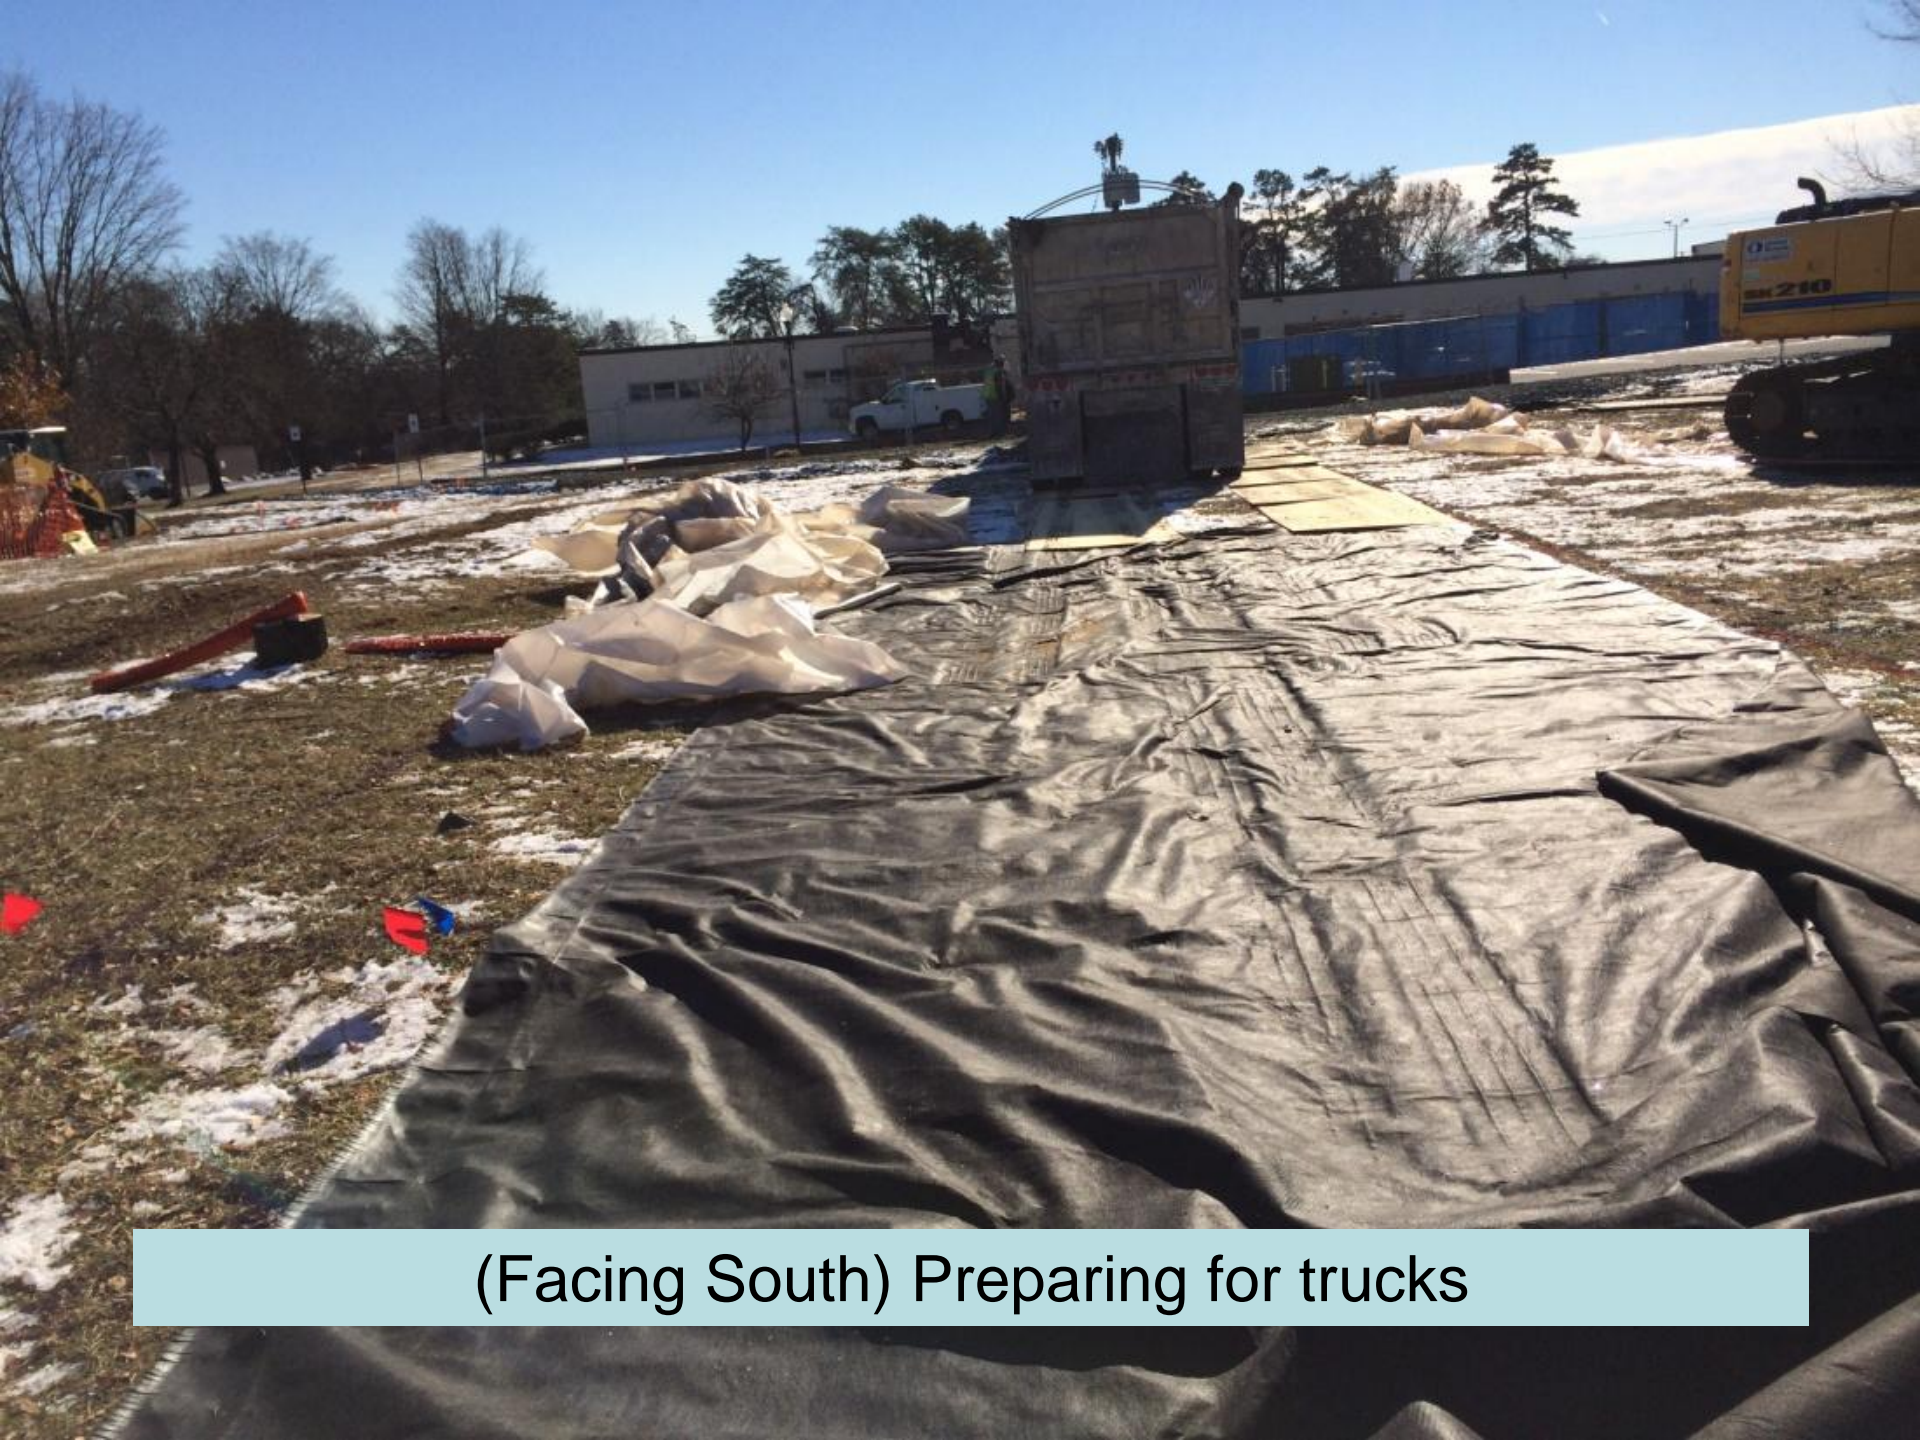
(Facing South) Preparing for trucks

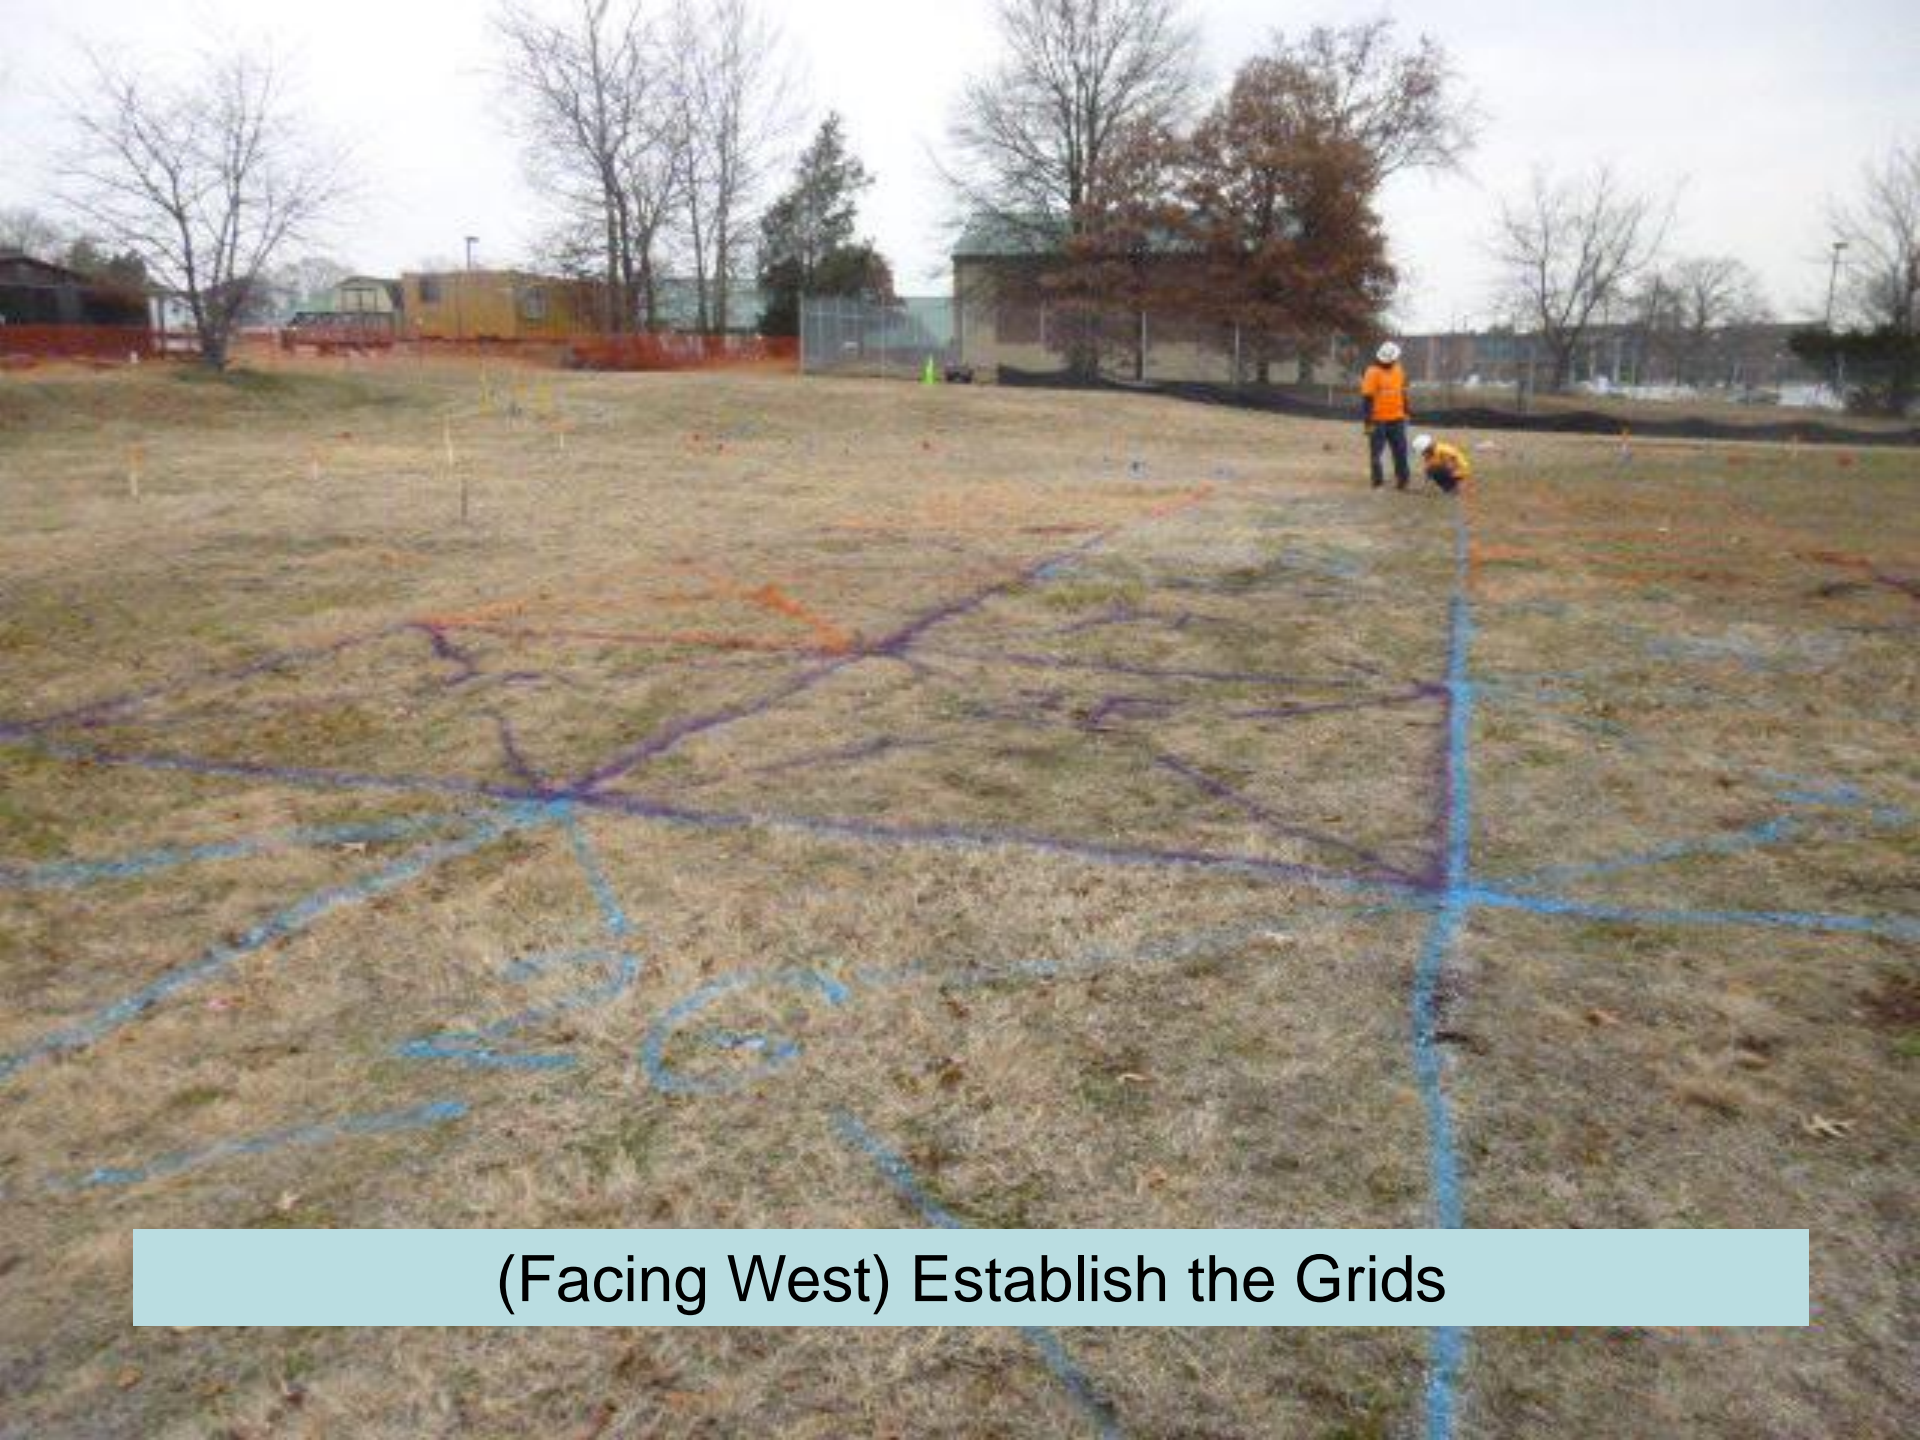
(Facing West) Establish the Grids

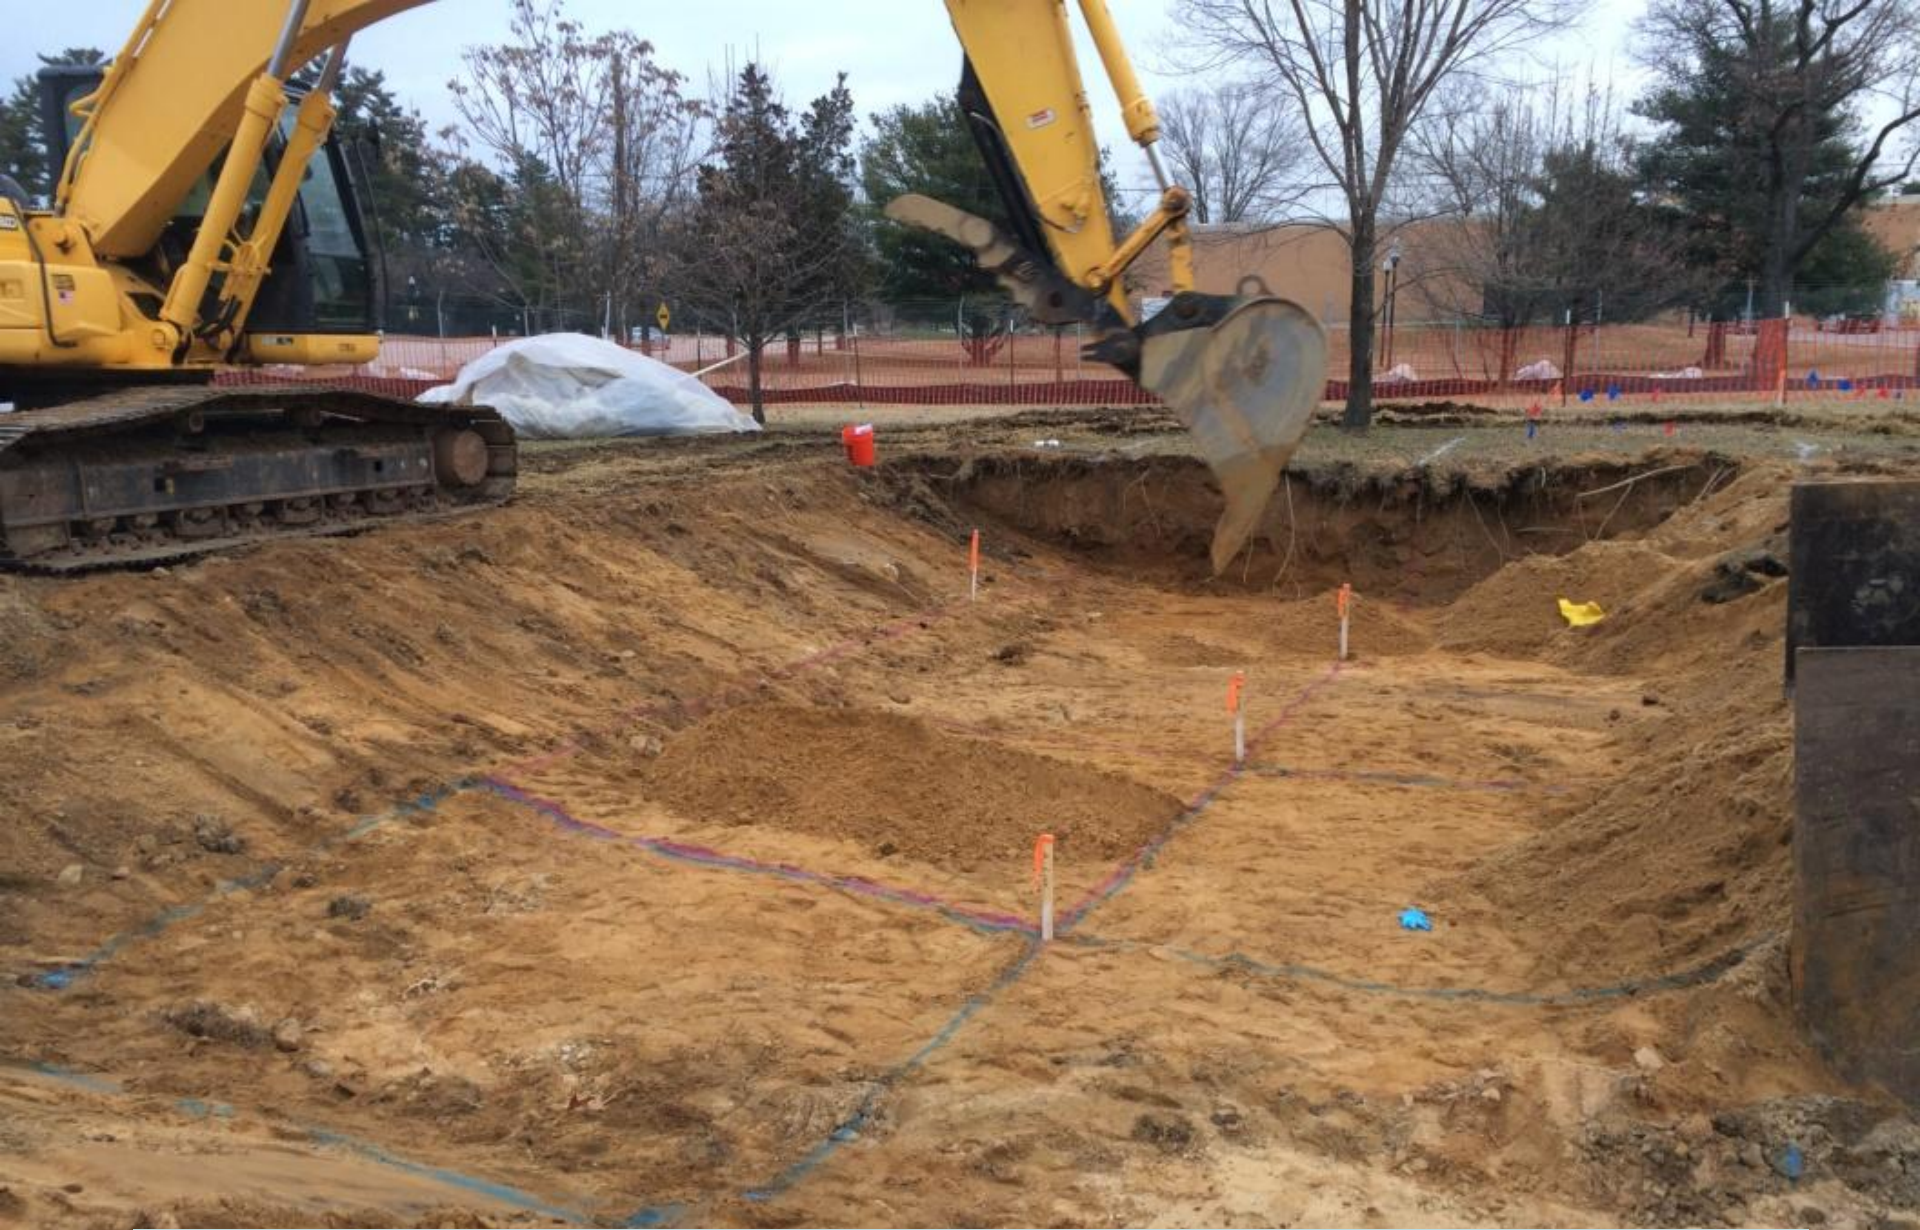
(Facing East) Maintaining the Grids

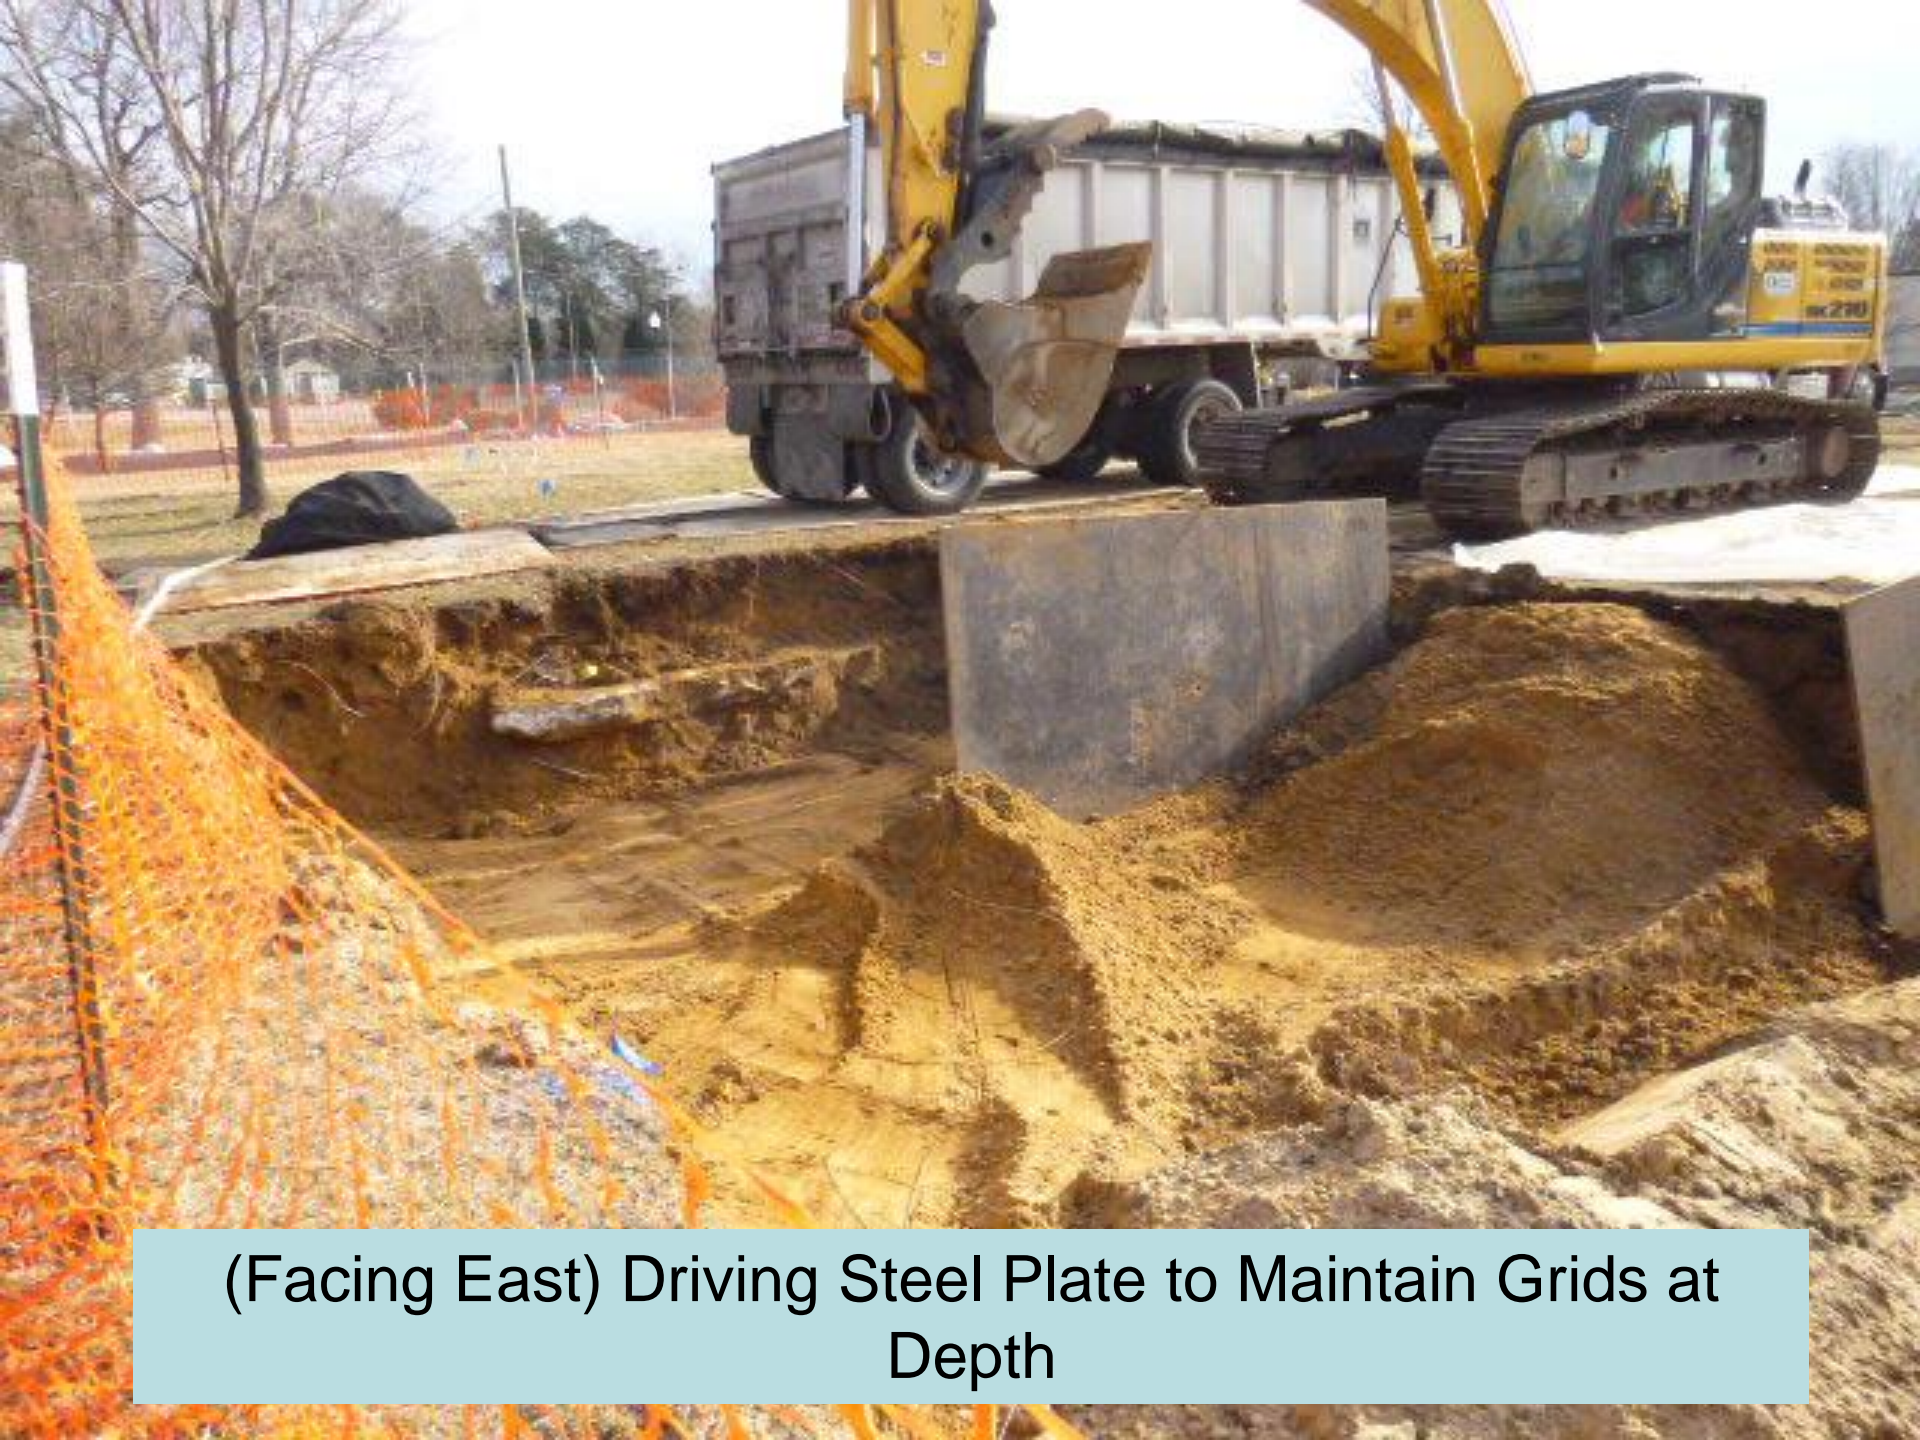
(Facing East) Driving Steel Plate to Maintain Grids at Depth

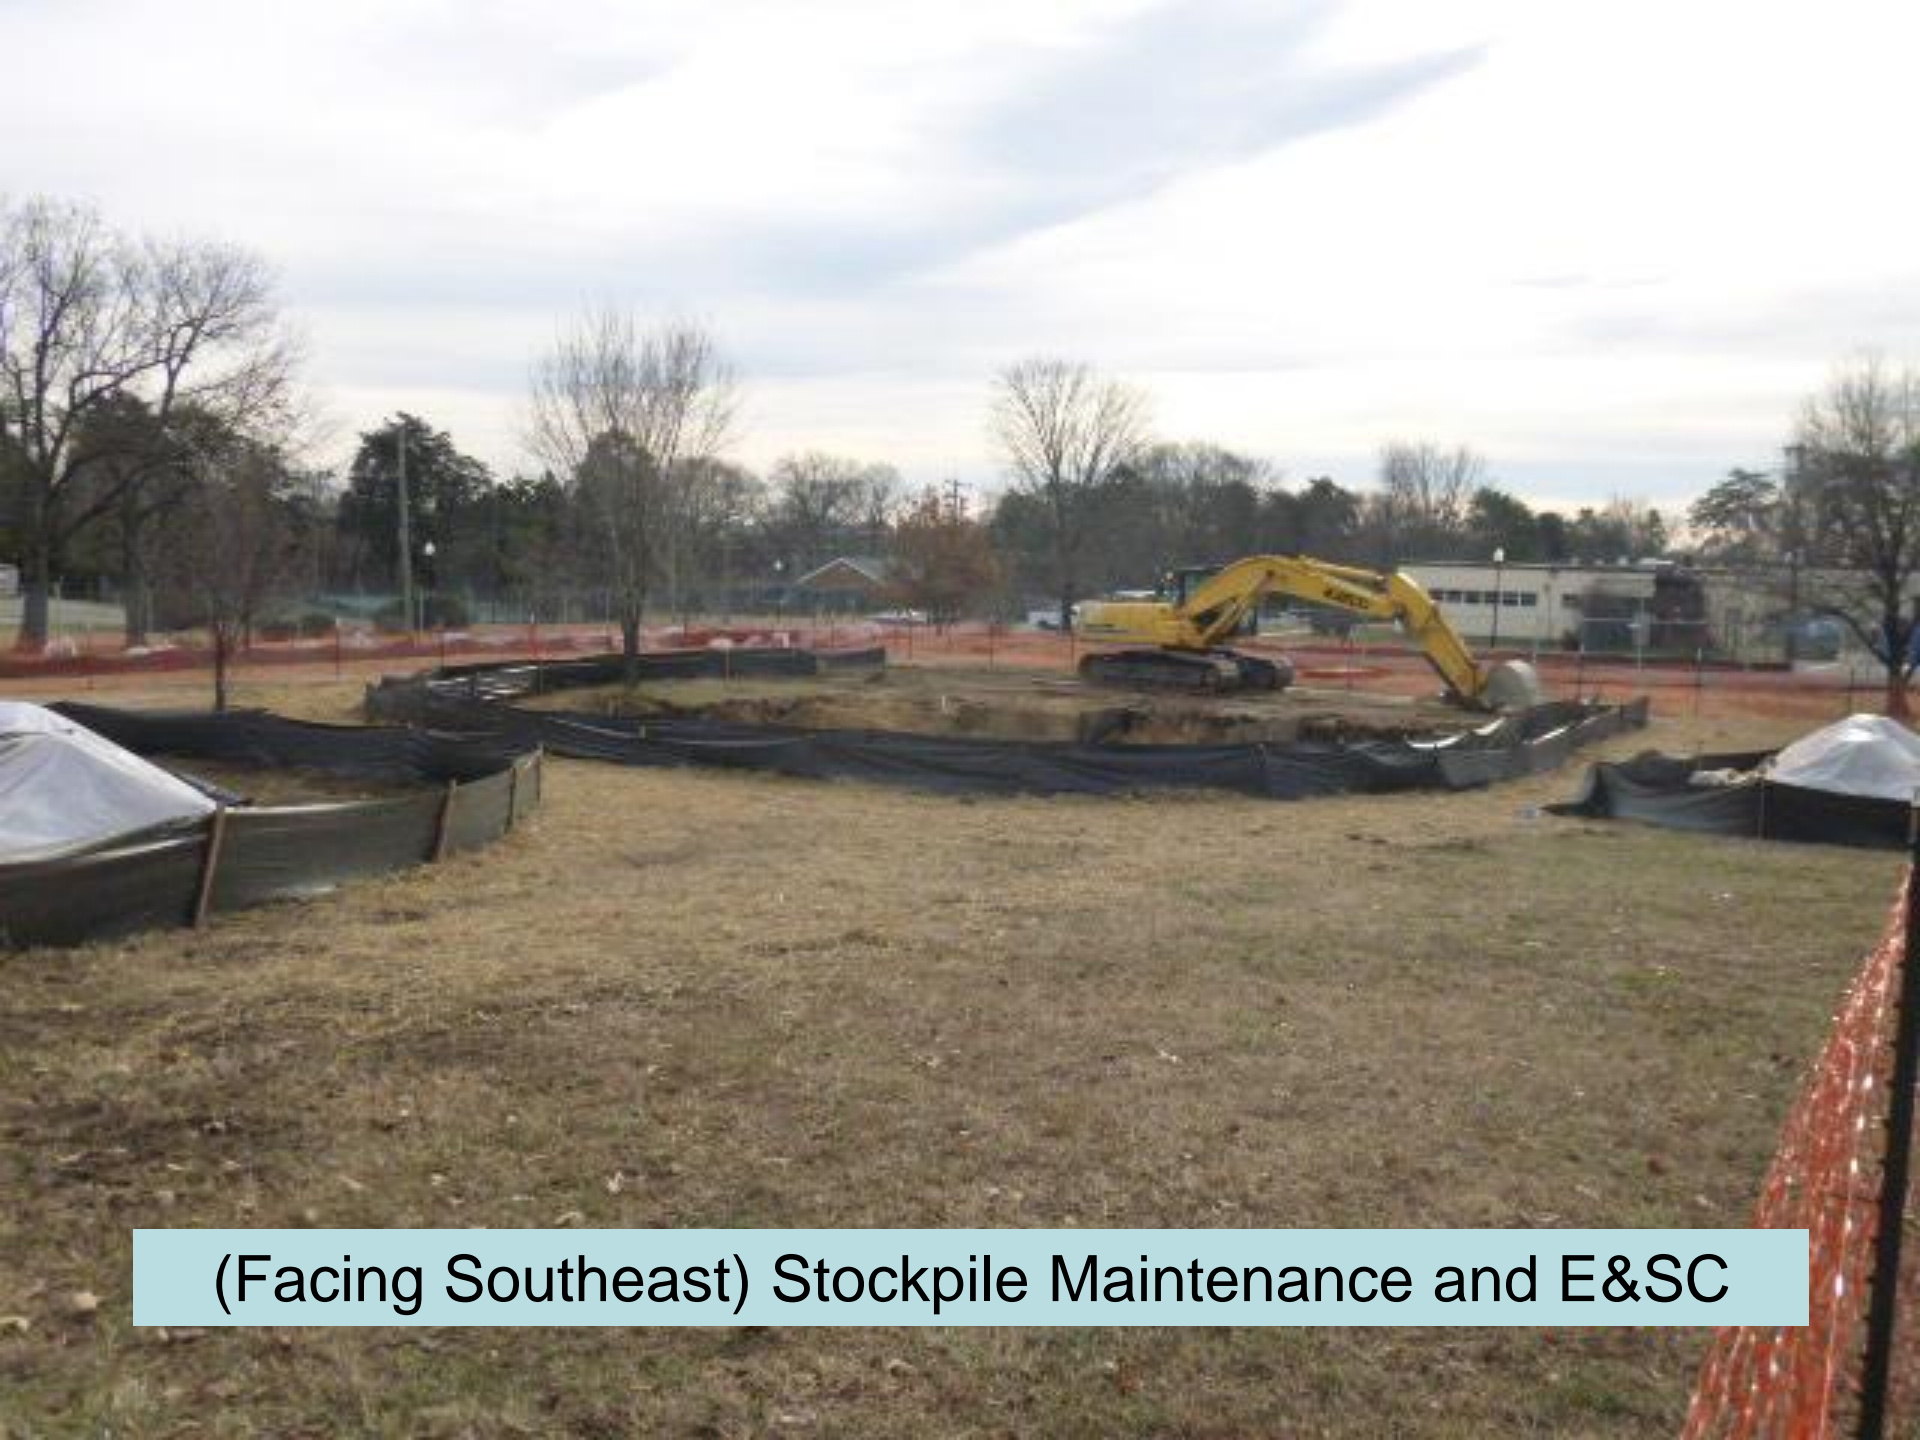
(Facing Southeast) Stockpile Maintenance and E&SC
